OUTLINE OF REPAIRS

1. FILM ADVANCE & SHUTTER RELEASE MECHANISMS

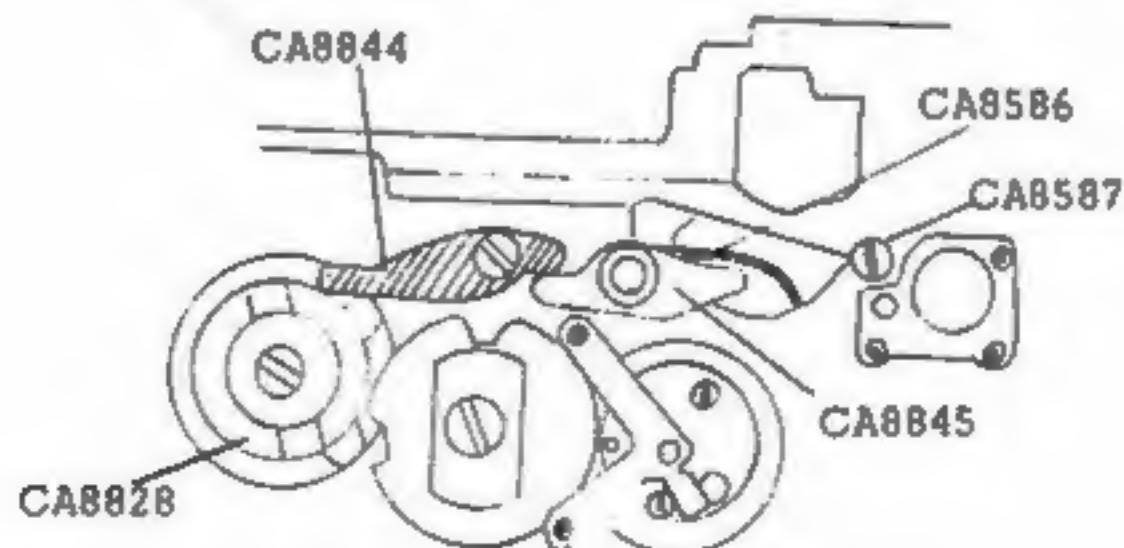
If, even upon replacement with 8844C, the film advance motion is not smooth yet, the portion marked A may be slightly hammered out. (Do not work excessively, as it will cause the spring to be readily pressed from the beginning of the motion.)

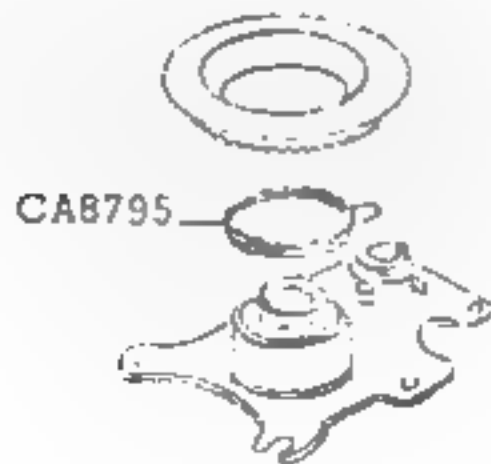
6) CA8795 (Spring) entangled

Check the relative part and adjust.

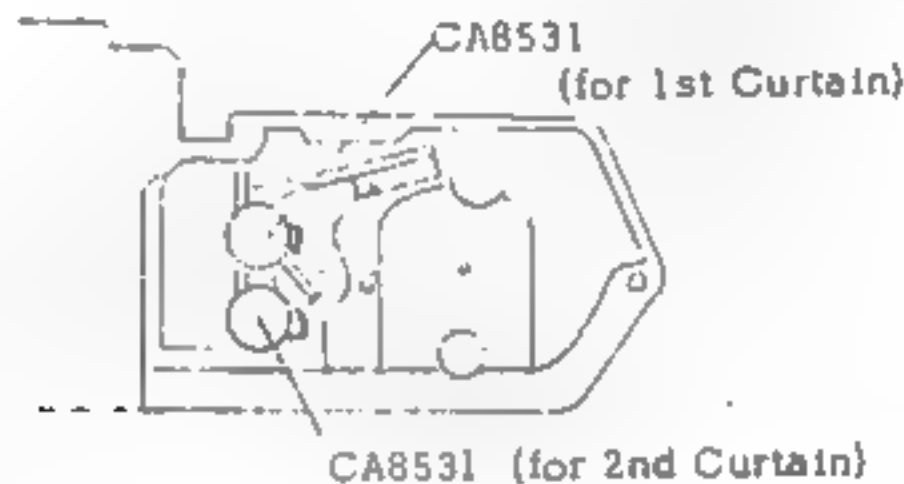
1) Improper adjustment of CA8531 (Nut)

Turn 8531 to the right to weaken the curtain tension and thus slow down the speed.

Turn 8531 to the left to increase the tension and thus speed up the curtain run.

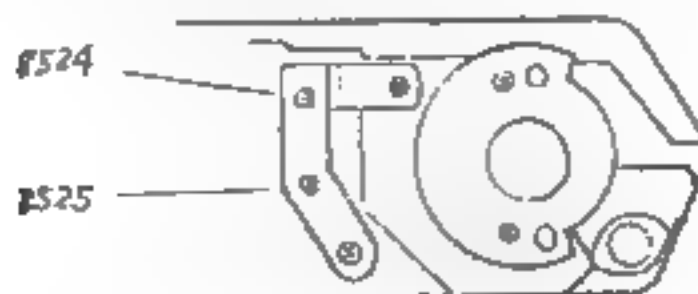
Adjustments may be made by 8525 (Shaft) and 8524 (Shaft). Turn them to the right for stronger tension and faster speed, and to the left for weaker tension and slower speed. Care must be taken not to deform the driver groove at the upper end of 8525 and 8524, as it will cause poor operation of the curtains.

Use the shutter tester 7F7L1 and/or 7F7L3. The speed should be 11.7~12.1 ms. at 1/1000 sec.

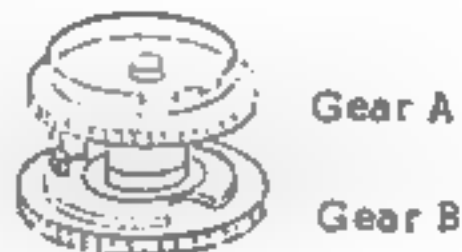
1) Adjustment of the curtain position.(Patch inclined.)

- (1) Turn 8519 (Shaft) to let 8592 (Claw) engage on to the Gear A and lock it. Do not directly touch the metal part of (8519) with fingers.
- (2) Remove 8857 (Shaft) on the lens side, turn 8521 (Stopper), lower 8520 (Shaft), and disengage 8520 from the Gear B.
- (3) Rotate the Gear B to bring its boss to the position coincident with that of the Gear A as shown below.

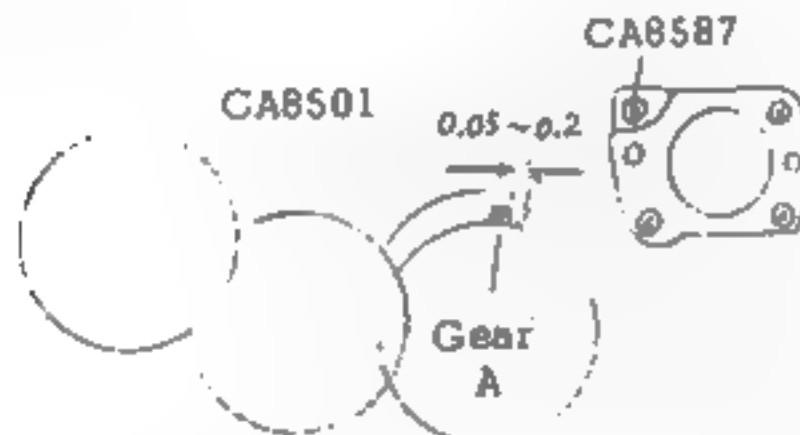
3) Brake adjustment unsatisfactory.

Upon adjustment of the curtain speed, when the shutter is released at 1/1000 or B, there should be a room of 0.05 - 0.2mm between 8501 (Base Plate) and the Gear A. If not, it should be adjusted to be within that range by 8587 (Screw). (It will change the spring tension of 8586 (Spring).)

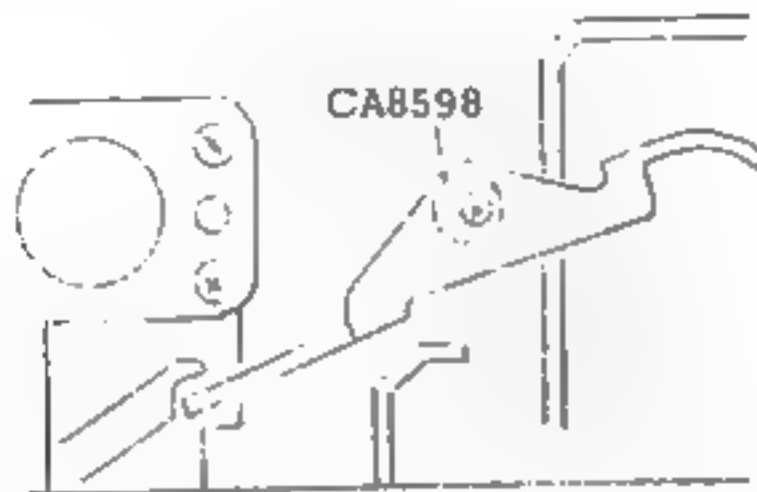
7) CA8595 (Lever) and CA8592 (Claw) stuck together.

8598 (Washer) is to be mounted in the manner shown below.

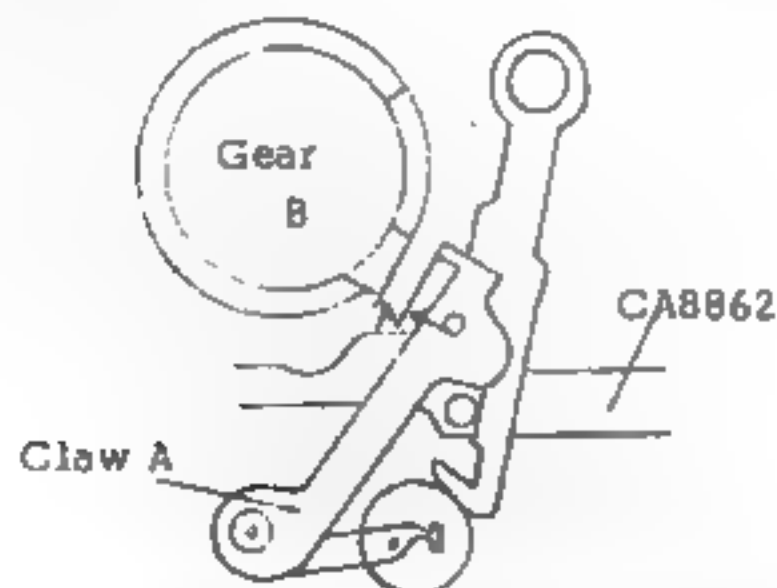
3. Adjustment of "B" shutter speed (Irregularity of ■ stop, immediate closing or remaining open)

- (1) Upon completion of shutter charging, 8862 (Plate) should return to the original position accurately. At this time there should be a space between Claw A of 8567 (Shaft) and the Gear B of 0.5mm or above. (See below, the portion marked A) If there is not, an adjustment must be made by bending the portion marked with a circle in the picture below.

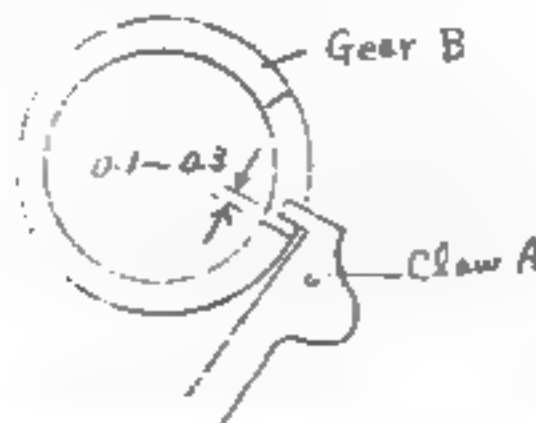
CA8567S
CA8567M
CA8567L

- 2) The space between Claw A and the Gear B.

Depending on the size of Claw A, there are three types of 8567 (Shaft). A proper selection should be made out of the three shown below, so that the space between Claw A and the Gear B would be 0.1-0.3 (as shown below).

An adjustment may be made by bending the tip of Claw A.

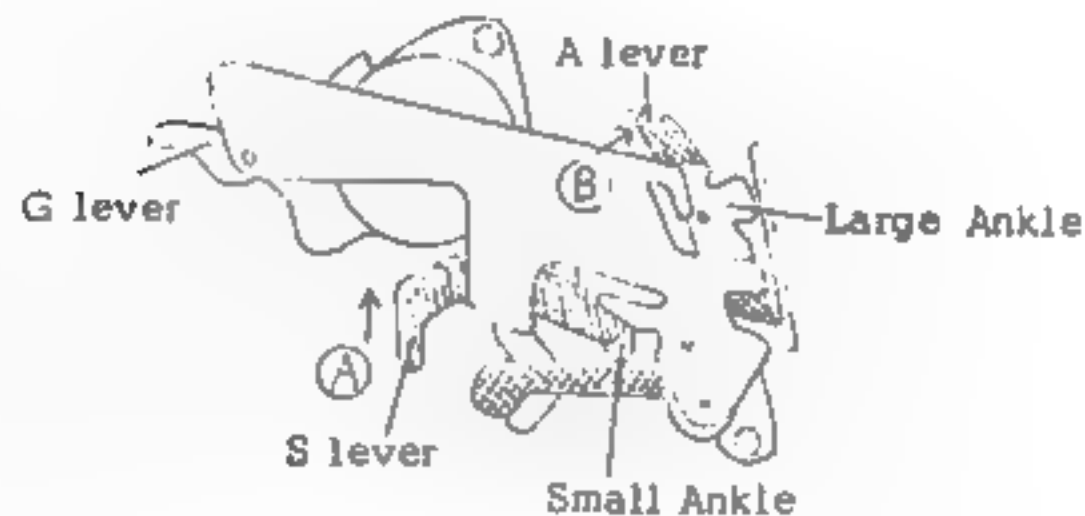
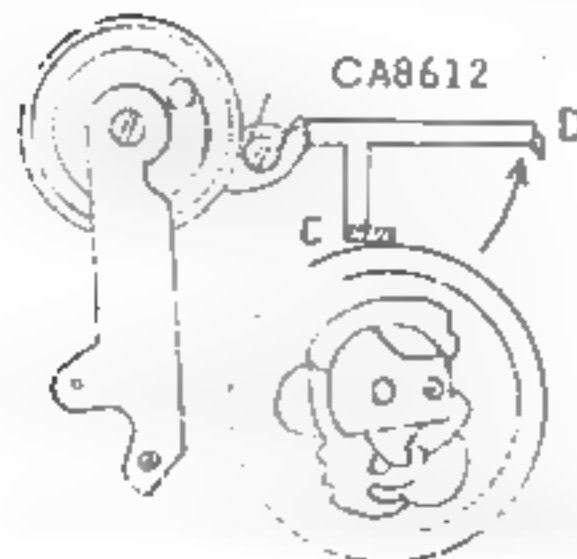
6. Improper timing at low shutter speeds:

Adjust by bending portions C and D of 8612 like that relative parts work as follows.

When 8575 is set at $1/1 - 1/8$, immediately prior to the shutter charging action 8612 starts working and portions A and B of the governor should move in the directions indicated by arrows to release the Large Ankle and Small Ankle of the governor.

With 8575 set at $1/1 - 1/8$, when the Governor of the Governor is worked upon completion of film advancement, the Ankle should not be engaged.

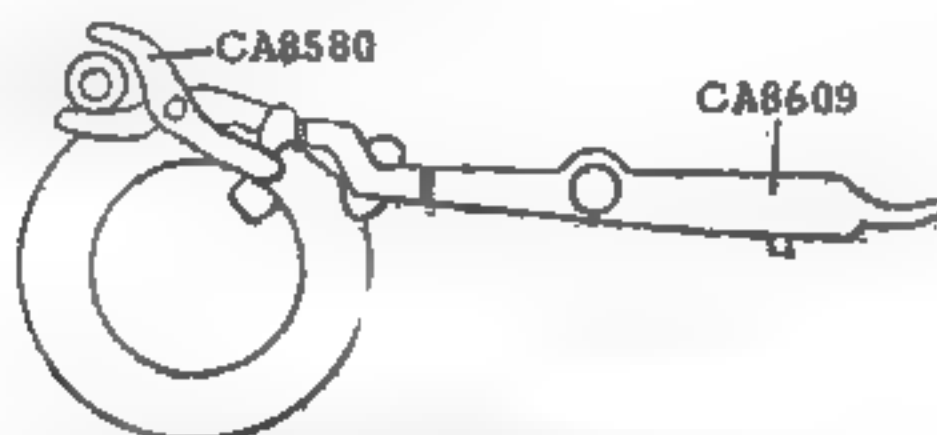
2) CA8580 lever rattling

Prior to film advancement, check the engagement between 8580 and 8609 by shaking vertically 8609. If such engagement is for less than $2/3$ the thickness of 8609, adjust the room at the rivet of 8580 to be within 0.3.

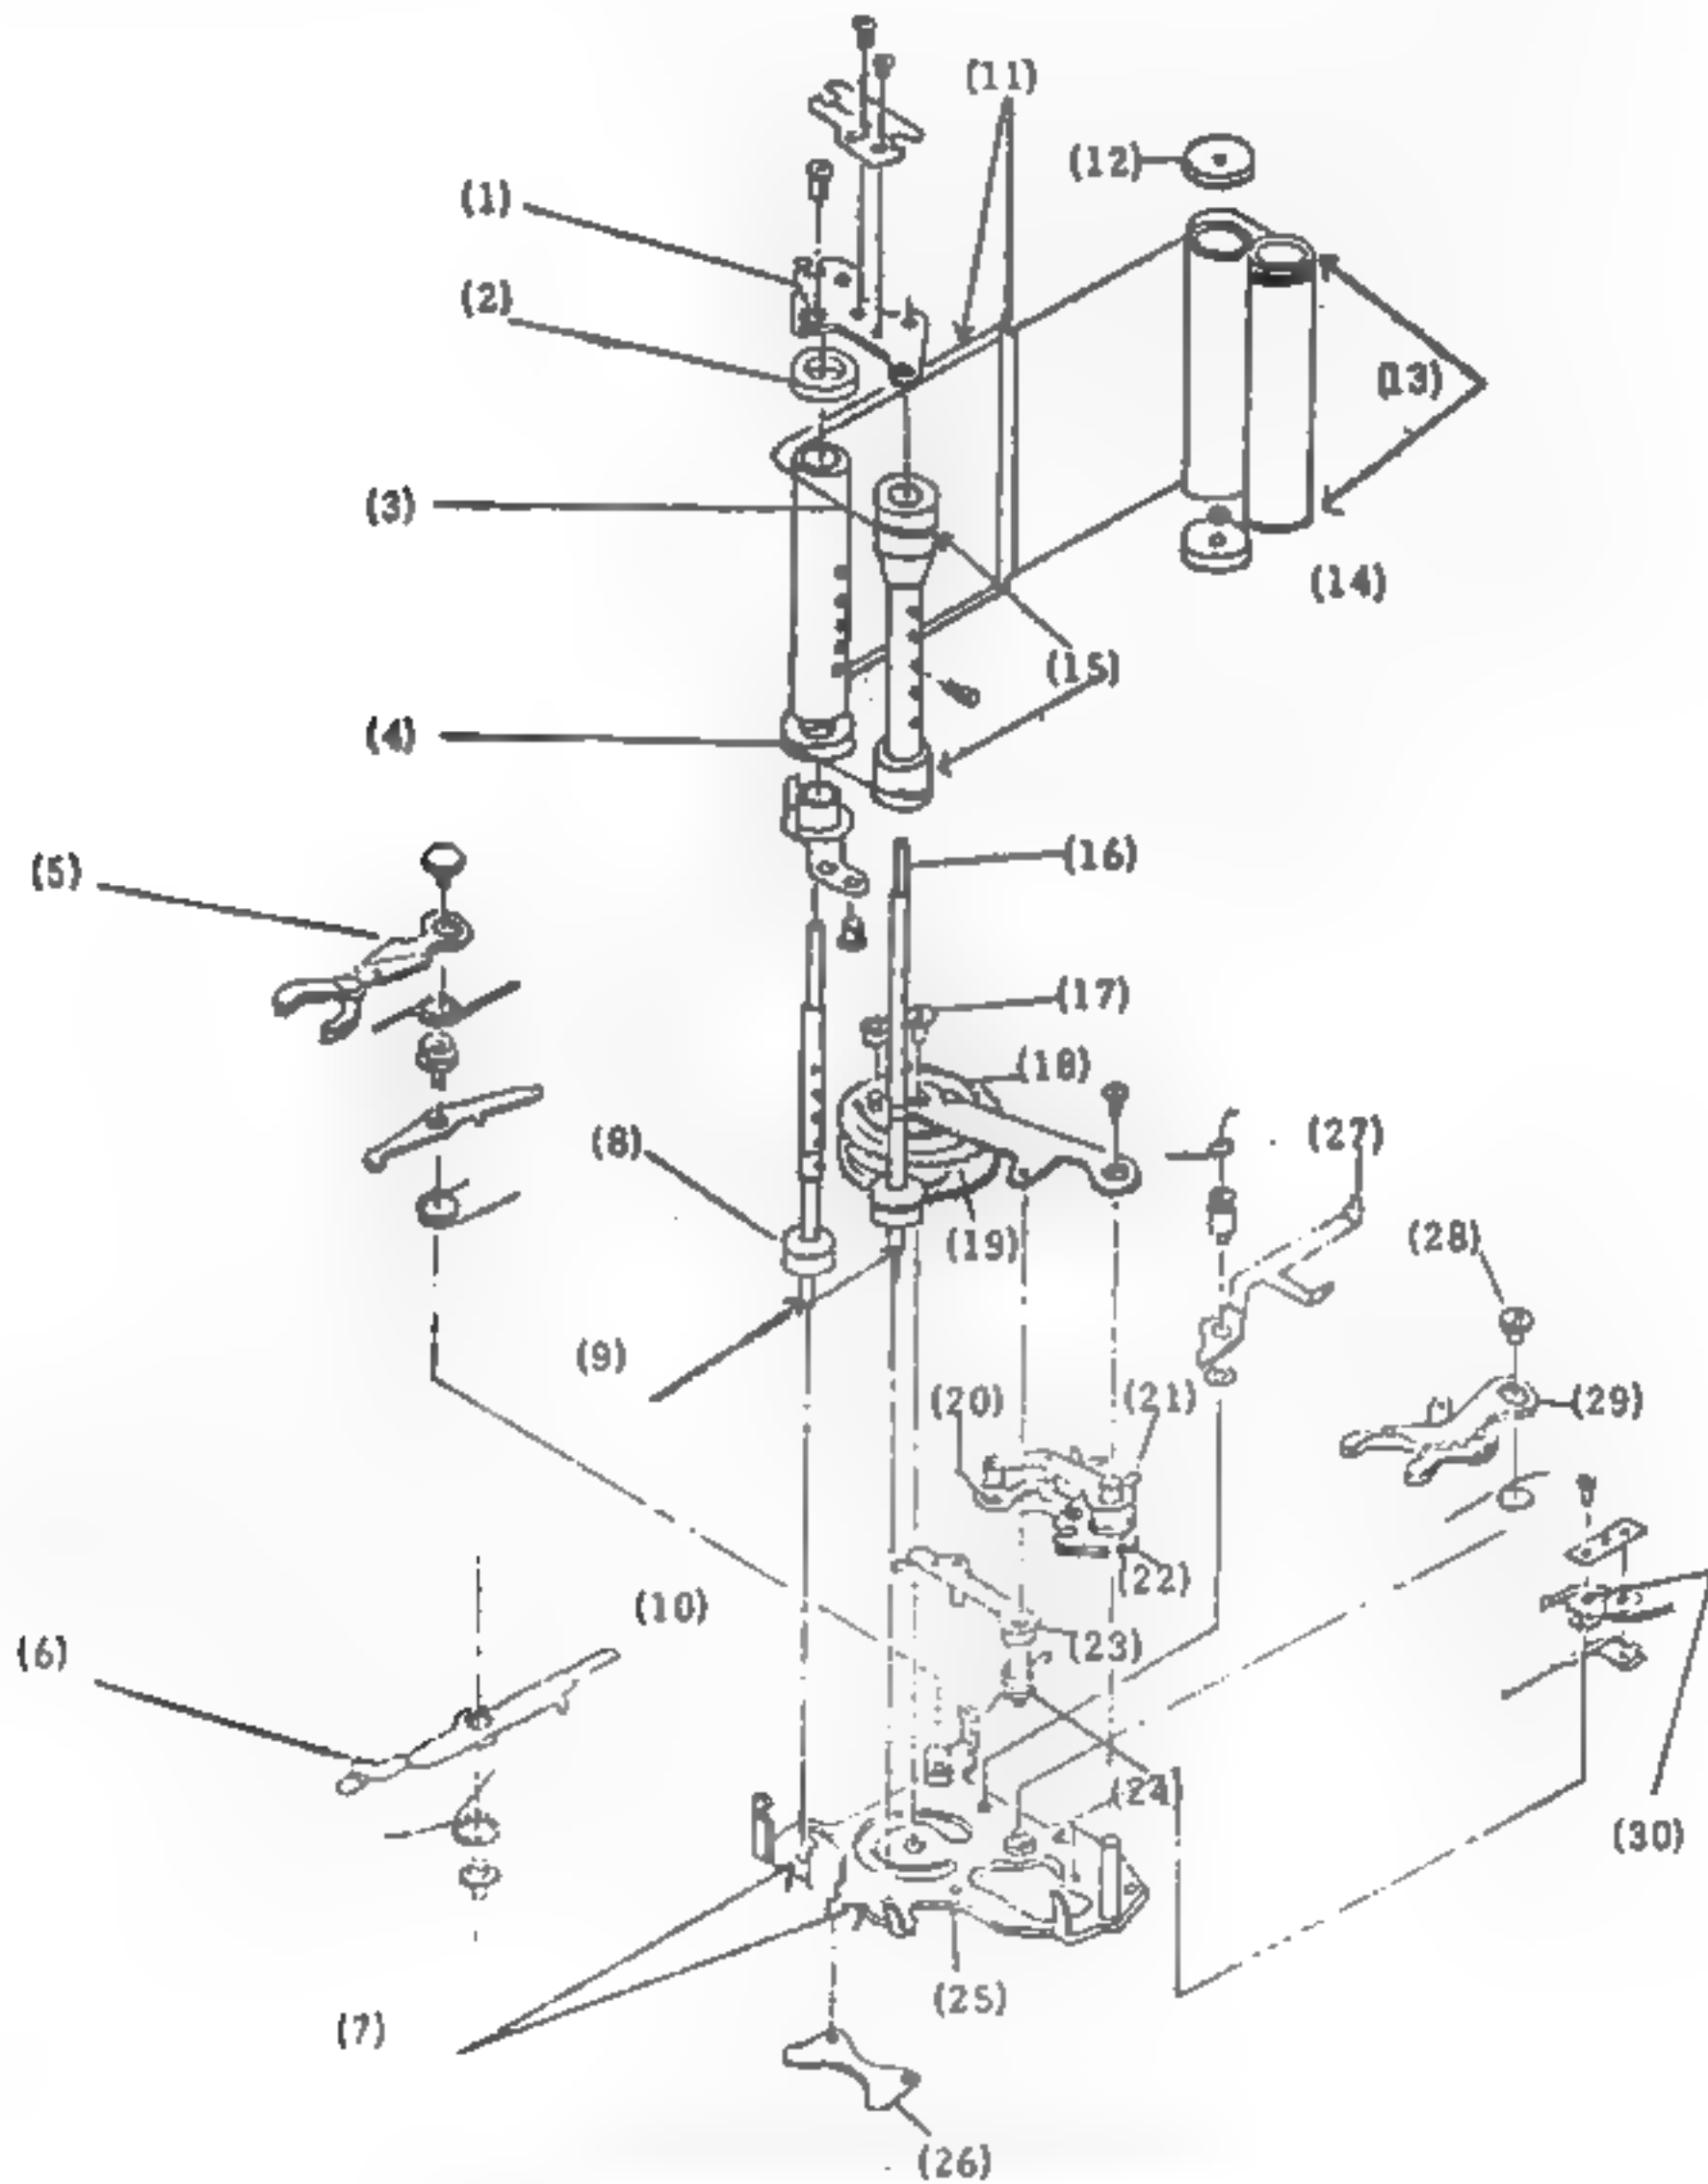
8. Irregularity in Curtain Speeds:

Check the following items and make necessary repairs or adjustments.

- (1) Mounting position of 8508.
- (2) Rotation of 8510. However, do not lubricate.
- (3) Whether 8537 (4 pieces) are off the roller.
- (4) Rotation of 8510. However, do not lubricate.

- (5) 8580. Check whether it with the Ring of the Shaft B.
- (6) 8609. Whether it is properly engaged on the lever.
- (7) 8501. Dirt or inaccuracy in surface finish at the guide holes for the Shaft A and B.

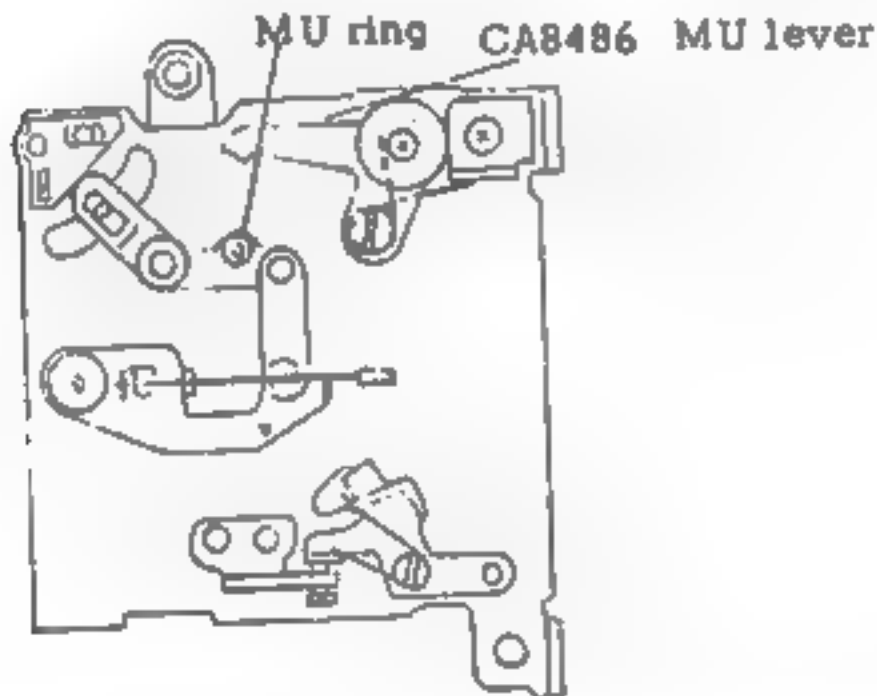
1) Improper selection of the MU ring

Make a proper selection of the MU ring to satisfy the requirement cited in the Checkup column below.

- (1) While the mirror is at the original lowered position, there should be a space of 0.2 or above between the tip of 8486 and the MU ring.
- (2) During the mirror-up operation, the mirror should be in such a position that its tip touches the damper and presses it accurately.
- (3) The MU knob should operate smoothly and should not get heavy toward the end of its motion.

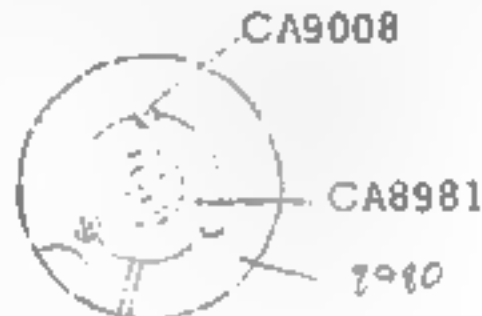
If the zero point is extremely out of position, adjust the position of 8981.

- (1) In case of + (an excessive swing), loosen 9008 and turn 8981 to the right.
- (2) In case of - (an insufficient swing), turn it to the left. Upon adjustment, turn the shutter dial to adjust the loosened string.

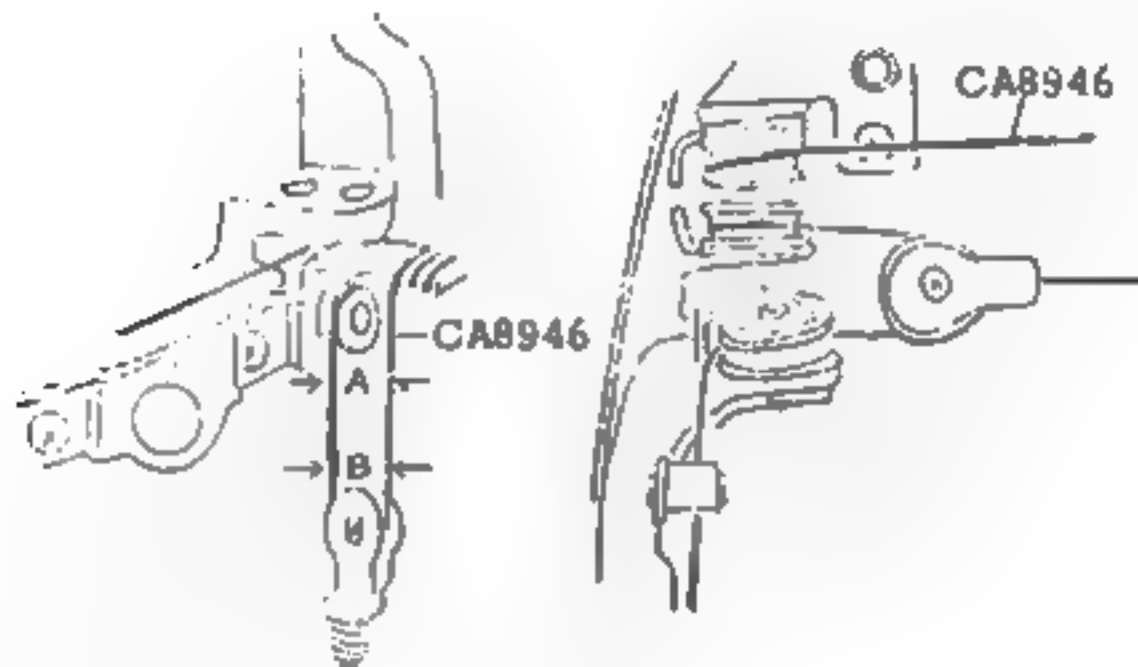
2) Adjustment of CA8946 (String) (dislocation and entanglement)

8946 is to be threaded as follows:

- o The string should not be dislocated from the pulley.
- o The width at A and B should be approximately the same.
- When 8879 is turned until it hits the Cam Roller, there should be a space of less 1 mm between pulleys of the B spring and the B spring plate.

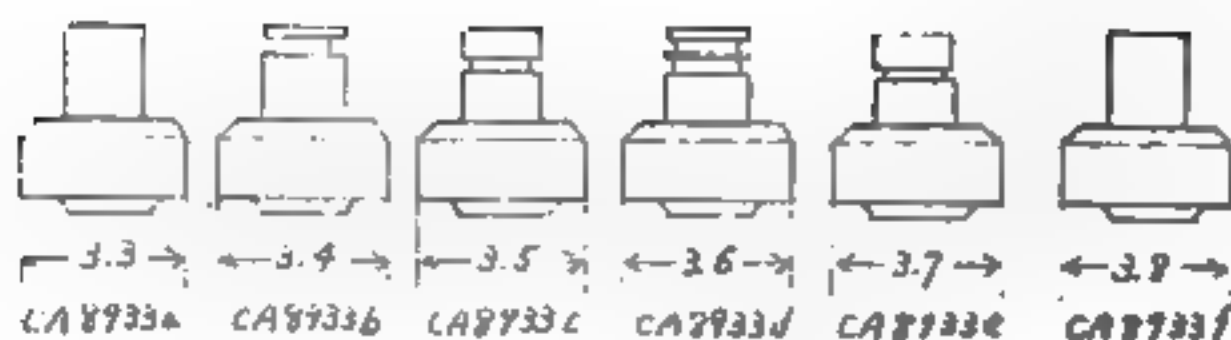
3) Improper selection of CA8933 (Roller) (diameter)

Referring to the checkup column on the right, make a proper selection and check the operation.

8933 should turn smoothly and accurately without an extreme difficulty such as stoppage and uneven movement.

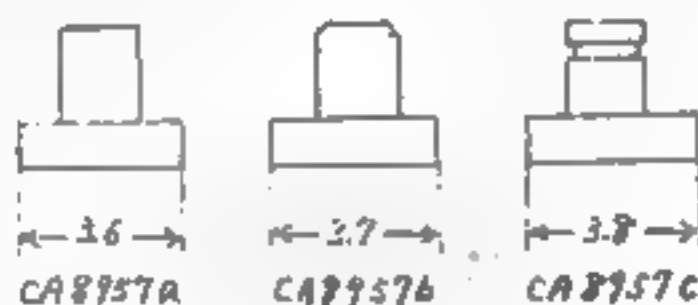
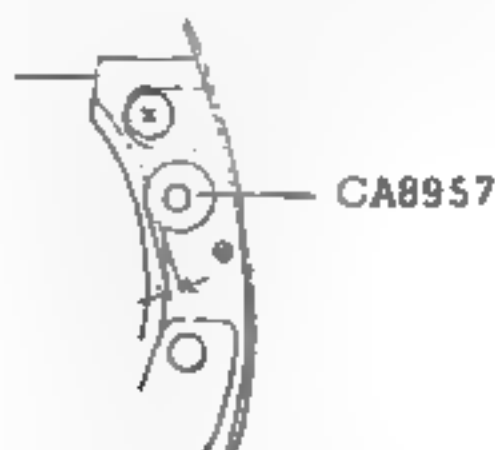
4) Improper diameter of CA8957 (Roller)

8957 comes in three types. Referring to the checkup column make a proper selection and check the operation.

A little space may be permissible between 8957 and 8879. (If the roller selection is made allowing no space between them, it sometimes causes poor returns of 8879.)

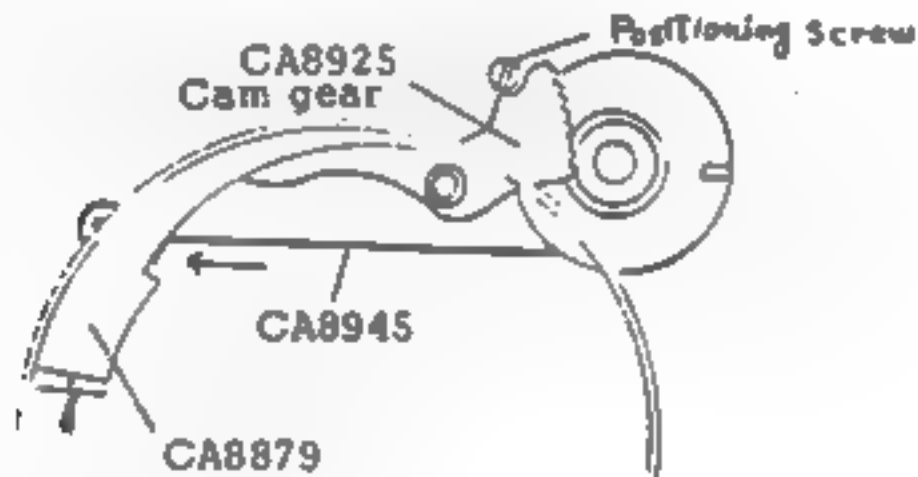
4. Improper Adjustment of the Cam gear positioning screw:

When 8945 is pulled fully toward the arrowed direction, the space between 8879 and 8925 should be with 0.3mm. An adjustment should be made to fulfill this requirement by the Positioning screw.

- o Upon adjustment, there should be a space between the A and the stopper pulley.
- o When 8879 is turned to its fullest extent, the A should not hit 8925.

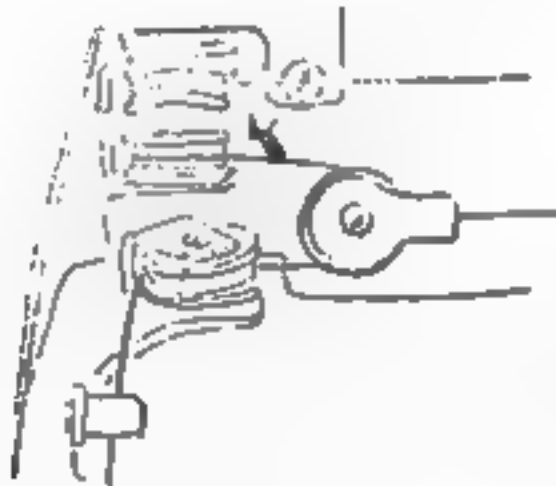
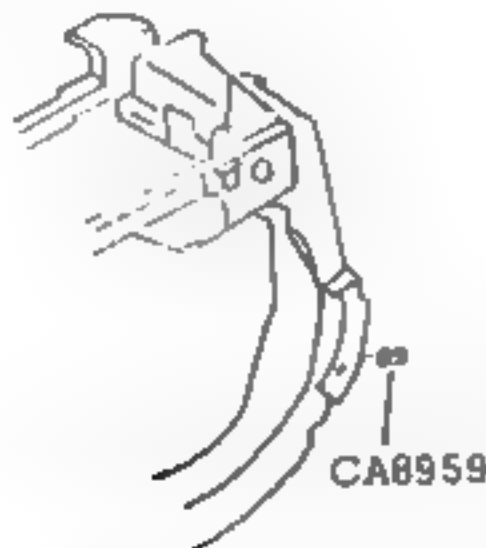
1) Adjustment of CA8944 (String)

8944 (the string for the dial gear) should be threaded as follows. When threading, it should be started from the arrowed direction to avoid crossing with the String.

- o If the meter is not mounted onto the Front Die-Casting, attach a 12 gr. weight at the tip of the string and check the operation.
- o Each pulley is to turn smoothly and accurately.
- Tolerance on the dial gear should be 0.1 or less.
- o When the dial gear is rotates, 8924 should not move.

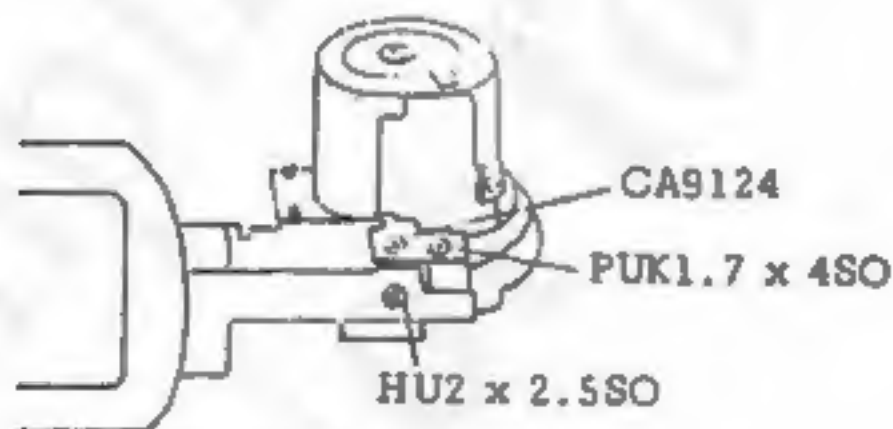
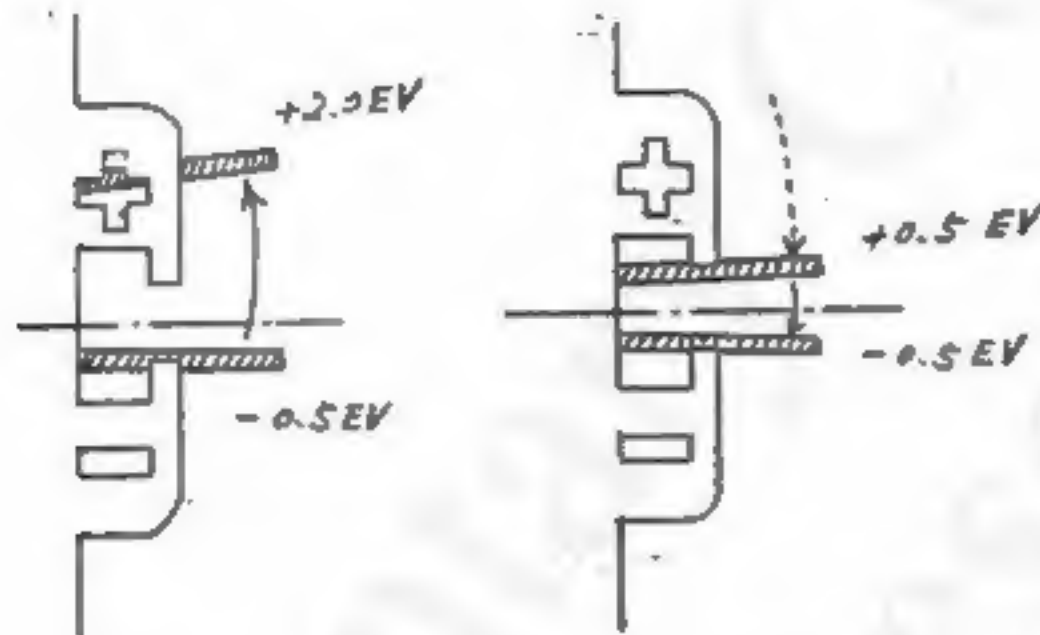
1) Adjustment of the L contact point position

Ref. Checkup column. Loosen two PUK1.7 x 4SO on 9124. Slightly move HU2 x 2.5SO forward or backward for adjustment.

- o Place the mercury battery in the camera and turn off the main switch.
- With ASA 100 at the shutter speed B, the aperture ring is gradually turned from F16 toward open. At this time, the meter needle should once jump to + 2.0EV above the index center before it stays at - 0.5EV. (See Fig. A)

- o When the lens aperture is stepped down from the wide open state, the meter needle should once swing down to a position lower than -0.5EV before it is stabilized at +0.5EV. (See Fig. B.)
